KINTZ CREEK DAM

NDI - PA 00415
PA DER 52-159
SCS PA-439

PHASE I INSPECTION REPORT NATIONAL DAM INSPECTION PROGRAM

MAY 1979

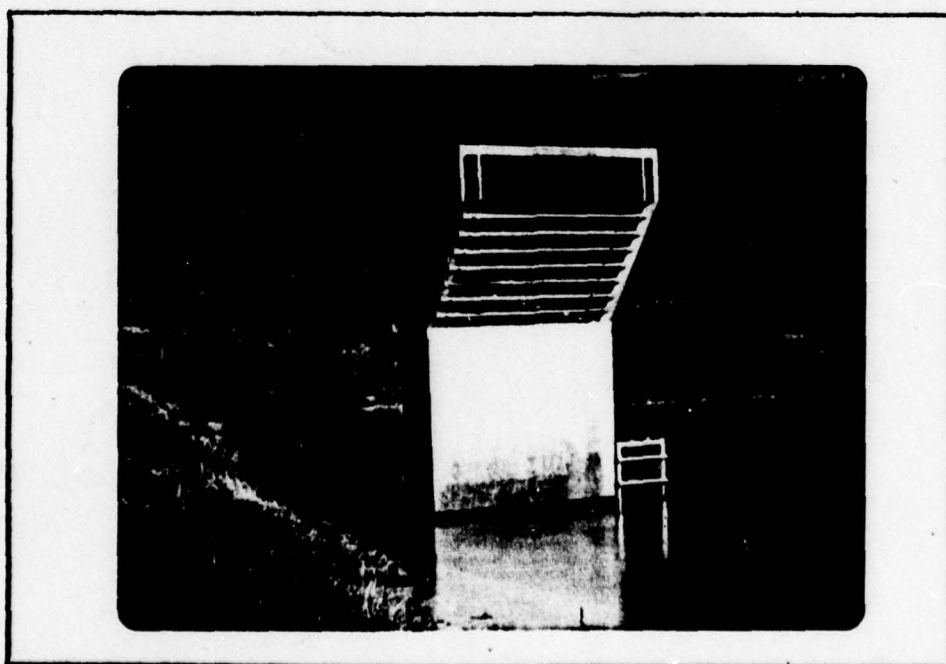
*RISER SHOWING DETAILS OF BOTH
THE HIGH STAGE AND LOW STAGE INLETS*

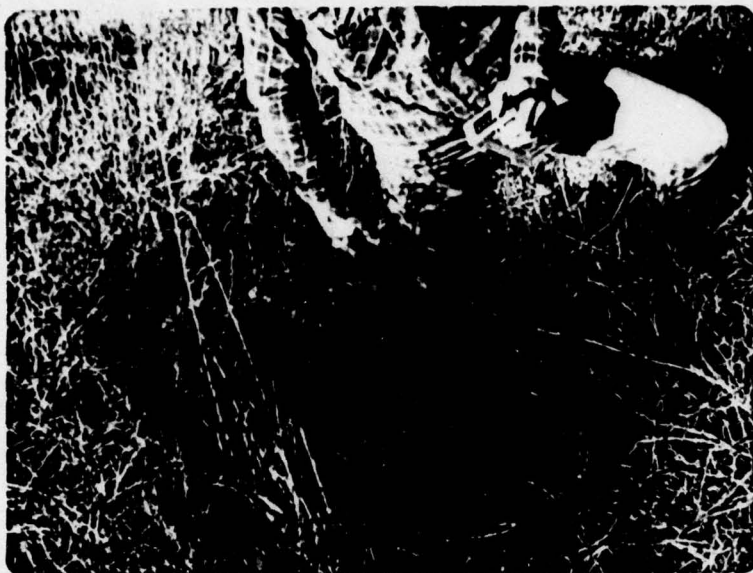
The area on the downstream face of the embankment, referred to as Zone V on the as-built drawings, consists of numerous holes (2 holes were approximately 2.5 foot in depth), exposed boulders with signs of soil erosion around the boulders, bulges, and overgrown vegetation. The layer of Zone V material does not appear in the design drawings. The grass cover on the upstream face of the earth embankment and on the Emergency Spillway appears to be in good condition while the grass cover on the downstream slope of the embankment appears to be in poor condition.

***DIFFERENTIAL SETTLEMENT IN THE
DOWNSTREAM FACE OF THE DAM***

DOWNSTREAM SURFACE
LAYER SHOULD BE REMOVED
AND REPLACED WITH
COMPACTED FILL.

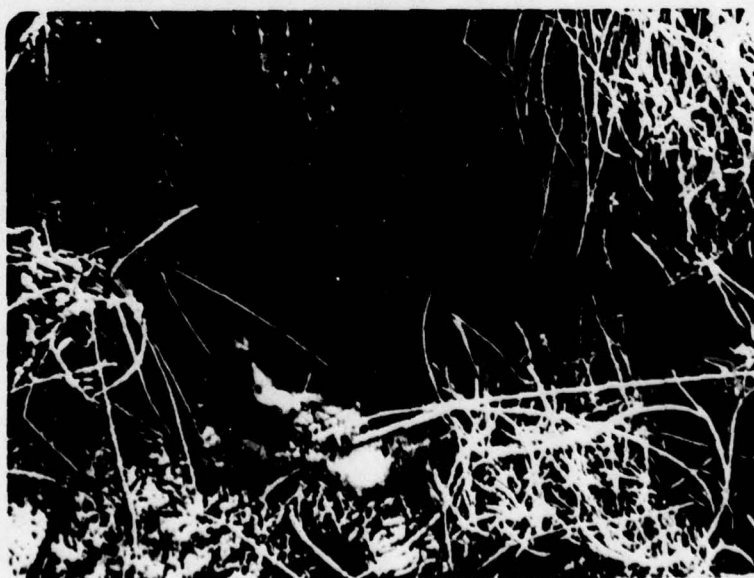
GAPS AND LARGE
HOLES WERE NOTED
IN DOWNSTREAM FACE.

***LARGE HOLES AND BOULDERS IN THE
DOWNSTREAM FACE OF THE DAM***

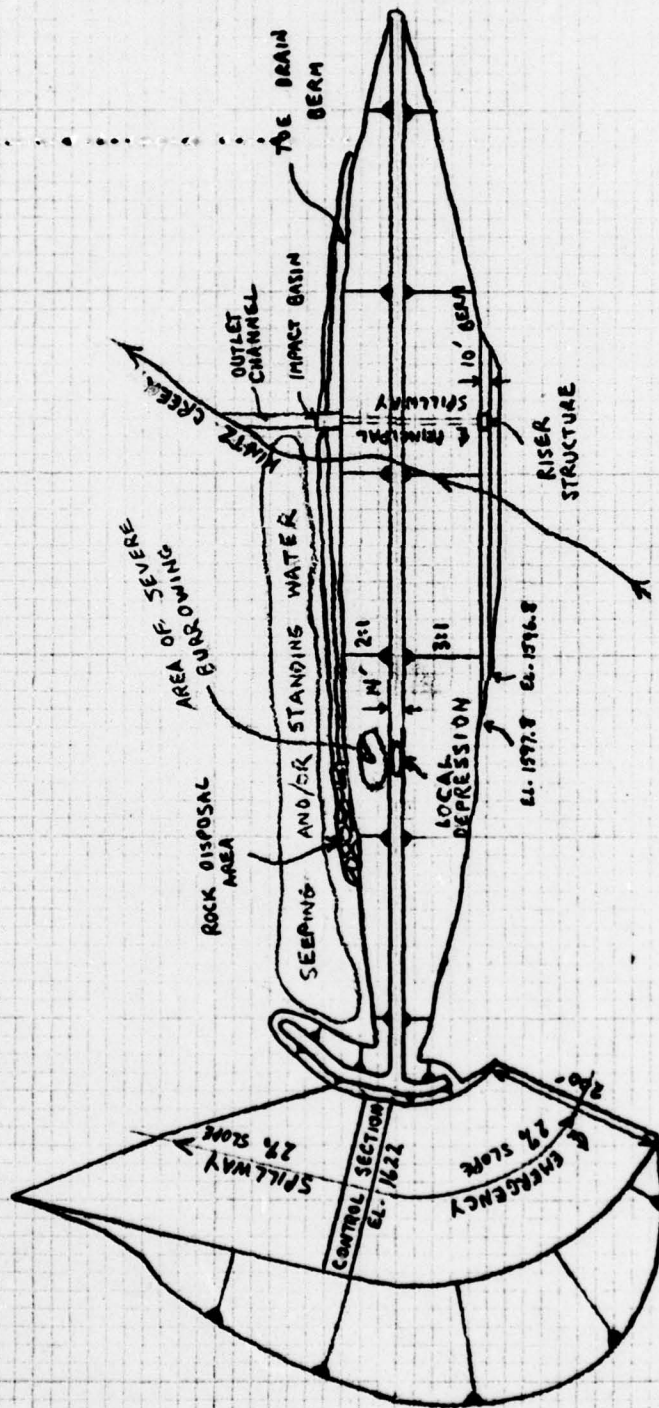
PLATE 6
GENERAL PLAN
DRAWING

- b. Dam. On the date of the inspection, the upstream face of the embankment appeared to be in good condition. However, on the downstream face there are numerous holes, exposed boulders, depressions, and bulges (refer to Plate D2). Variations of several feet were observed in localized areas and there was evidence of soil erosion around the boulders. A survey of the top of the dam revealed variations in ground elevations of nearly a foot. Several depressions in the top of the dam correspond to areas of animal burrowing in the downstream face. The top of the dam also has tire ruts (up to 6 inches deep) with standing water.

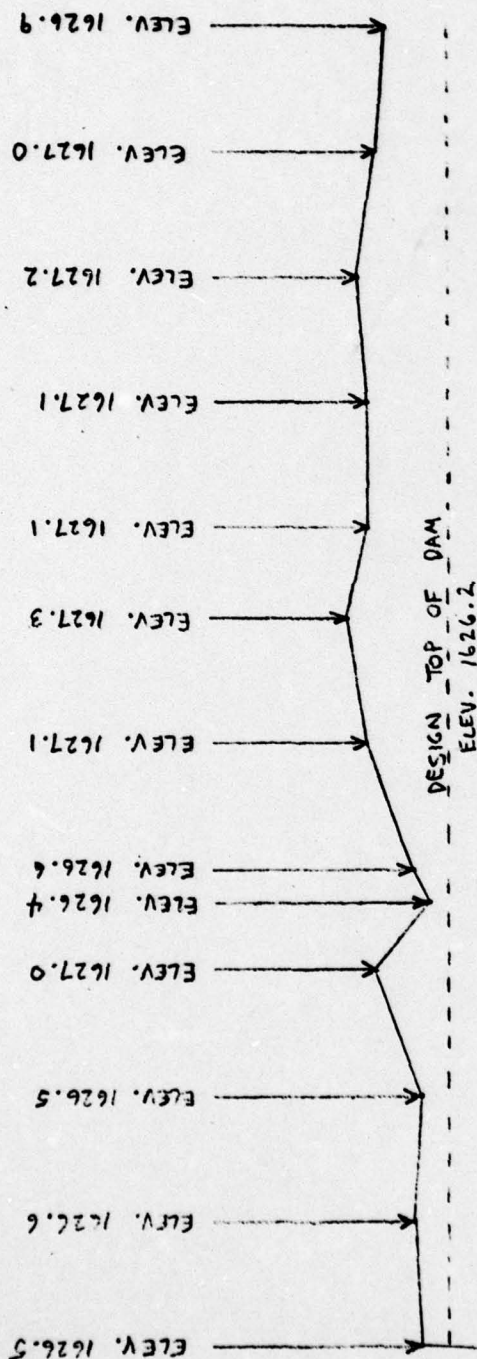
TOP OF DAM PROFILE

CREST UNDULATIONS WERE
NOTED, WITH APPARENT
AREAS OF DEPRESSION NEAR
THE LEFT ABUTMENT.

A DETAILED SURVEY
WITH RESTORATION TO DESIGN
ELEVATION IF NECESSARY IS
RECOMMENDED.
